MEMORANDUM FOR CELRE-EOS, File

SUBJECT: Soo Locks Complex, West Center Pier (WCP) 5 July 2020 Atlantic Huron Vessel Strike Trip Report

1. A site visit was conducted on 14 July 2020 to investigate damages related to the vessel strike by the Atlantic Huron, which occurred on 5 July. A visual inspection of the damaged area was performed, as well as video inspection through dive inspectors of the below water structure. Dive operations were performed by the SAO dive team. A marine surveyor from Hayes Stuart, Inc. named Capt. Francis D'Souza was present during the time of inspection. Observations, findings, and recommendations with applicable photos are included in the report below. Additional supporting drawings and reference information has been provided in Appendix A.

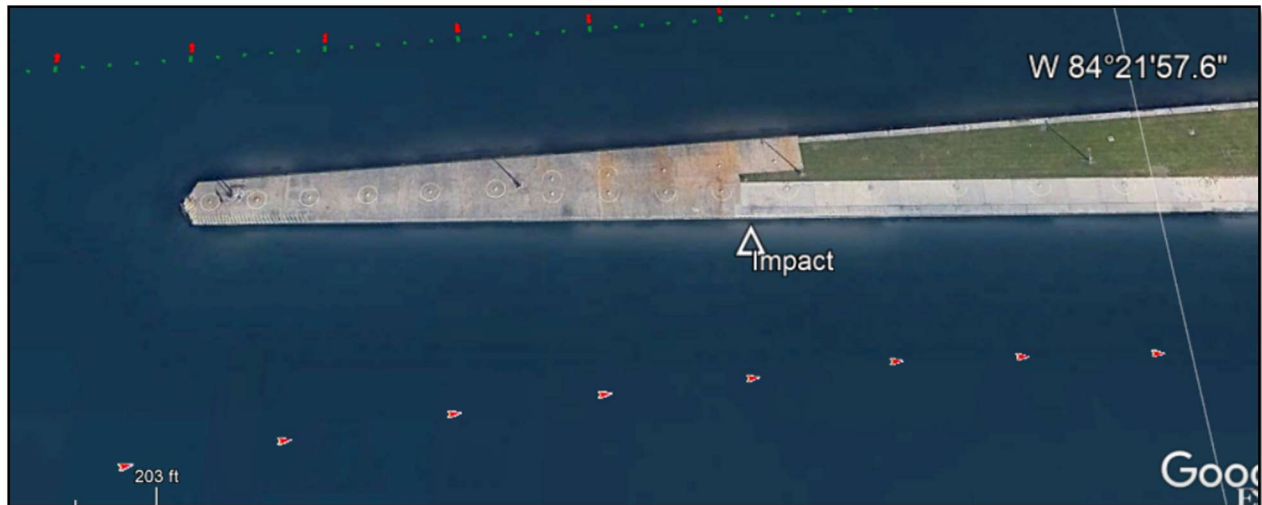
- a. Visual Observations Above Water: The impact location occurred at the southwest corner of the first timber crib east of the steel sheet pile (SSP) cells constructed during the 1964 west center pier (WCP) extension (Figure 1). For structure identification and naming convention, see Figure 2. This crib is identified as crib #6 from the 1906 WCP crib drawings. The timber fender was crushed and split at the location of initial impact (Figure 3). Fraying and rub marks were present past the initial impact location where the vessel rubbed along the fender (Figure 4). At the location of impact, the concrete cap of the existing timber crib was shifted north approximately 5 ¾" and rotated clockwise (Figures 3 to 5). This caused the SW corner of the cap to be crushed into the SSP Cell (U-20) cap (Figure 6). Three large spalls were visible: two in the adjacent U-20 cell cap along the perimeter of the 1994 concrete cap repair area (Figures 8 to 12), and one along the rounded edge of the crib #6 cap. There was visible mounding of the soil in the center grassy area of the WCP directly north of the concrete pavement (Figure 7). The mounding soil could be felt and visually observed from directly behind point of impact extending East approximately 50ft behind the existing crib wall. Flexible joint sealant material was visibly displaced from joints (compressed, torn, stretched, etc.) showing relative movement between concrete caps, pavement, and mooring bollard foundation (Figures 13). The mooring bollard foundation ranged between 5/8" and ¾" higher on the south edge relative to the north edge based on land survey data (Figures 14 & 15). An increase of ¾" in the expansion joint width north of the bollard was measured. The vertical displacement may be due to rotation of the foundation from lateral loading applied by the pavement and/or the concrete strut below the pavement (See Appx A. Figures A-1, A-2). The condition of the mooring bollard struts is unknown due to their inaccessibility.

Figure 1 – Aerial View – Location of Impact along West Center Pier

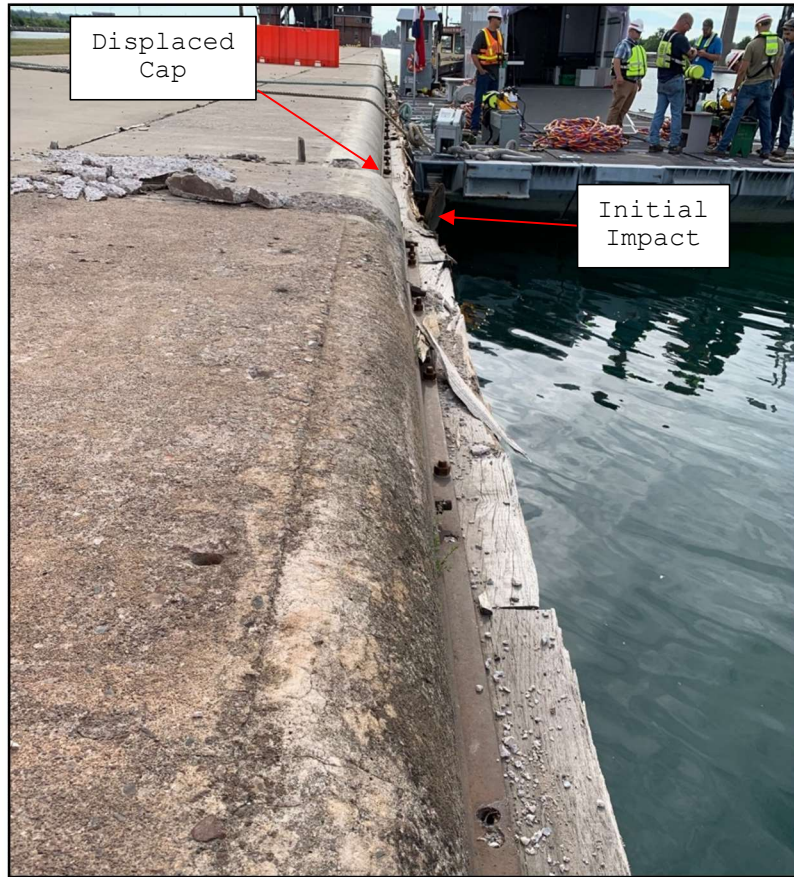
Figure 3 - View looking downstream (East) along WCP. Location of impact evident by crushed timber fender and displacement of timber crib wall concrete cap

- b. Correction of damaged timber fenders: The timber fenders show signs of splitting and fraying from impact. New timbers shall be installed to replace damaged timbers a minimum of 50 linear feet.

- c. Correction of mis-alignment: The timber fender and cap have moved sufficiently that the rubbing surface is no longer straight along the wall face. The existing steel angles and timber fenders will need to be removed and an extension of the concrete cap created to bring the face back into alignment. Upon installation of the new concrete cap extension, new angle iron, fenders, and fender bolts can be installed. See Figure 21 for a conceptual repair.

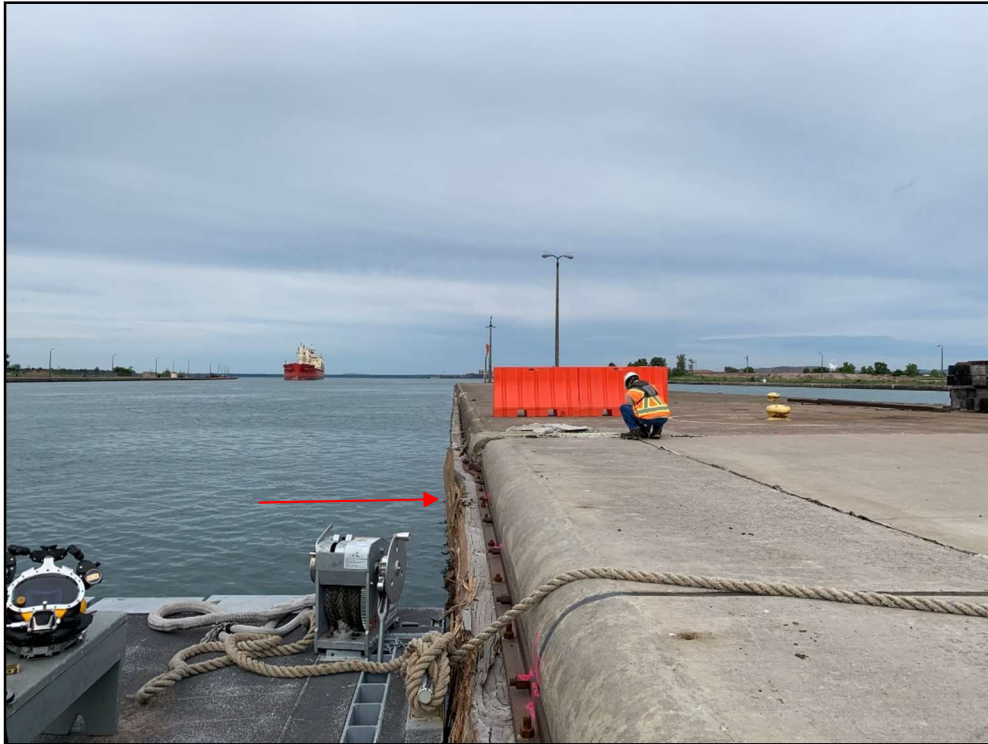
Figure 4 – View looking upstream (West) along WCP. Displacement of cap and connecting fender assembly clearly visible

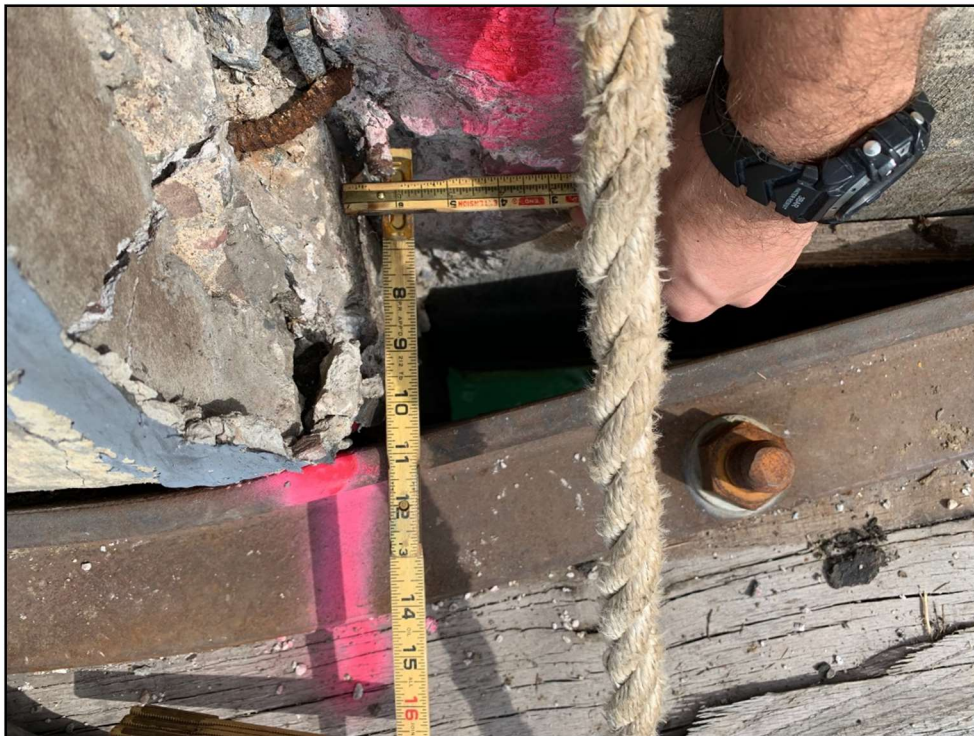
Figure 5 – Displacement of approximately 5 $\frac{3}{4}$ " of timber crib #6 cap northward relative to cell U-20 cap south face.

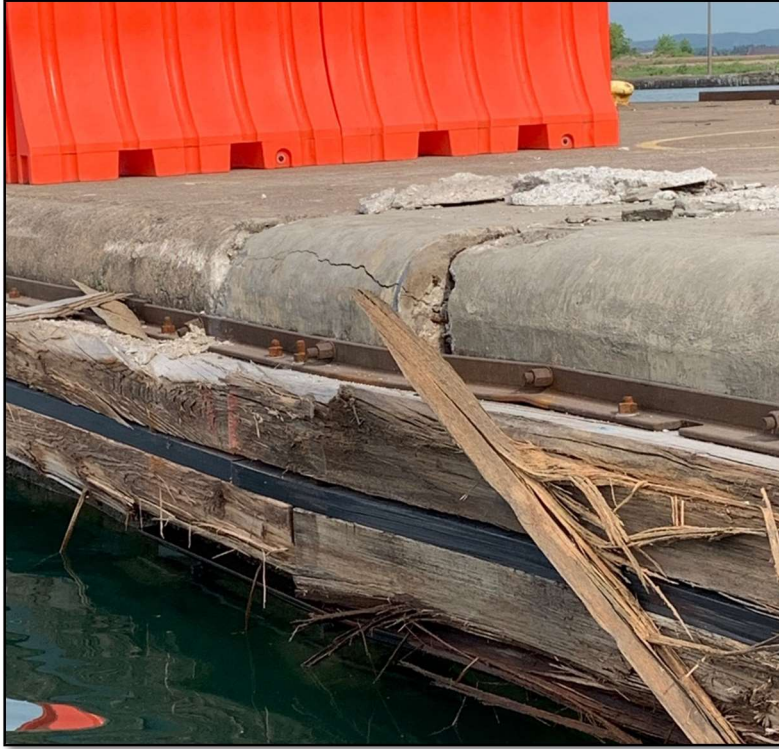
Figure 6 – Adjacent U-20 cell cap crushed and split. Spalling visible on surface and edges. Displacement of timber crib cap visible, damaged finders and fender brackets.

- d. Correction of damaged concrete cap. The existing concrete cap and pavement sections were pushed north and rotated clockwise upon impact of the crib cap southwest corner. This led to the crushing and spalling of adjacent concrete surfaces. Concrete spall areas will require repair (Figures 8 through 12). Typical spall repair shall be followed with 2" deep saw-cut perimeter lines, chipping out of damaged concrete to a minimum of 1" below existing rebar. Rebar and concrete shall then be cleaned prior to new concrete placement. Concrete shall have a minimum compressive strength of 4500 psi.

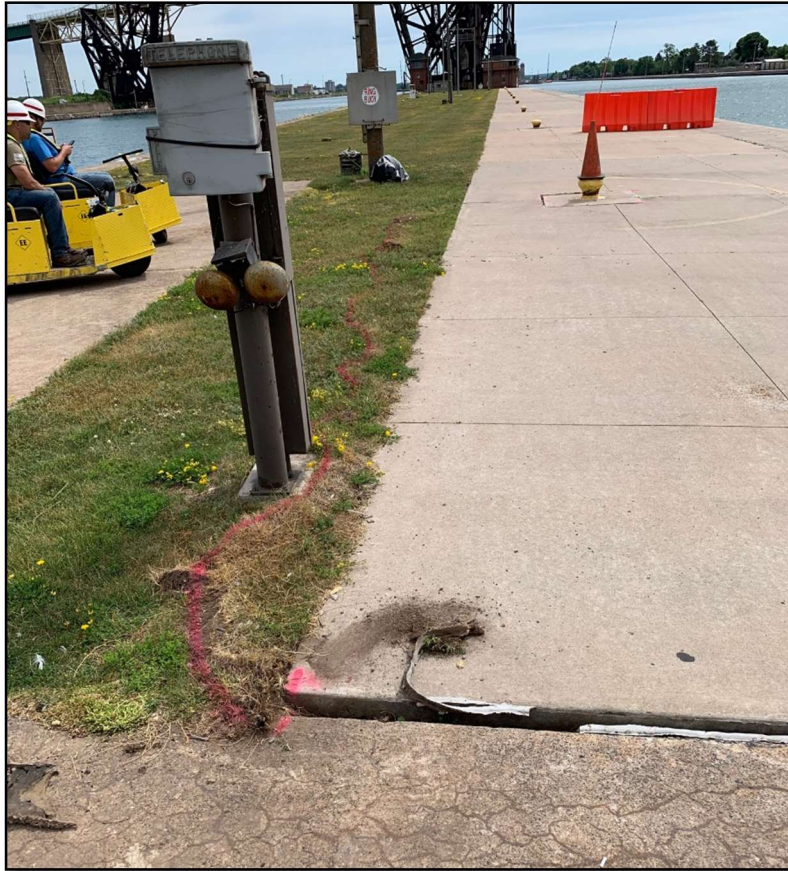
Figure 7 – Soil displaced behind concrete pavement north of crib wall cap (denoted by pink paint). Separation of NW corner of pavement from U-20 cap showing rigid body rotation of pavement

- e. Correction of damaged concrete joint material: Where the concrete cap has moved, the existing joint material has either been detached, torn, or compressed beyond serviceable limits. Therefore, all joint material for the rotated crib shall be removed and new joint sealant installed (50 linear feet of wall). Sealant shall be either one or two part polyurethane with an appropriate sized backer rod in accordance with manufacturer's instructions.
- f. Correction of bollard foundation movement: If the existing struts are in tact without damage, there does not appear to be a need for correcting the bollard alignment for operational or structural purposes.
- g. Correction of soil mounding: Soil in the backfill of crib 6 has physically moved (mounded) where pushed by the concrete crib cap and slab. The soil shall be tilled, graded, and seeded.

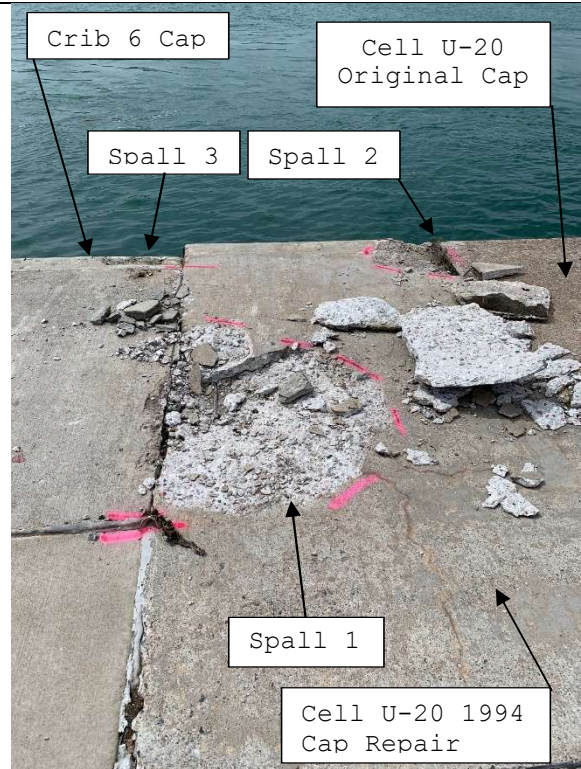
Figure 9 - Spall 1, 45" x 34" x 2.5" Deep. Approximately 9" of rebar exposed. East edge of U-20 cell cap repair area

- (1) The 1994 repair area of the SSP cell cap has a 1/8" wide crack along the full length and approximately 6 inches deep. The concrete shall be cut and/or chipped out to sound concrete along the full perimeter of repair area and replaced. Chipping shall extend a minimum of 1 inch below existing rebar to provide adequate bond.

- (2) As an alternative to chipping around rebar, concrete and rebar may be saw cut and removed. However, new rebar must be installed by drilling and epoxying into existing concrete to match the size, quantity, and approximate spacing of existing bars.

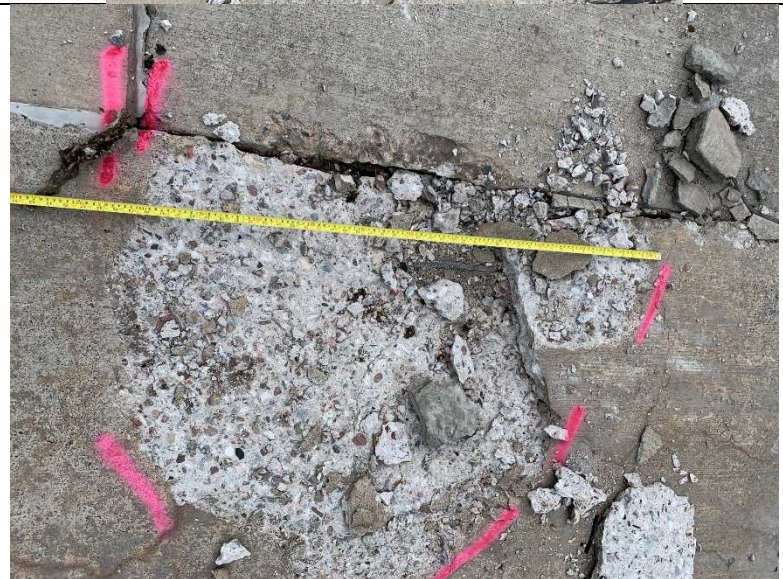
Figure 10 - Spall 1, Exposed rebar and concrete debris visible

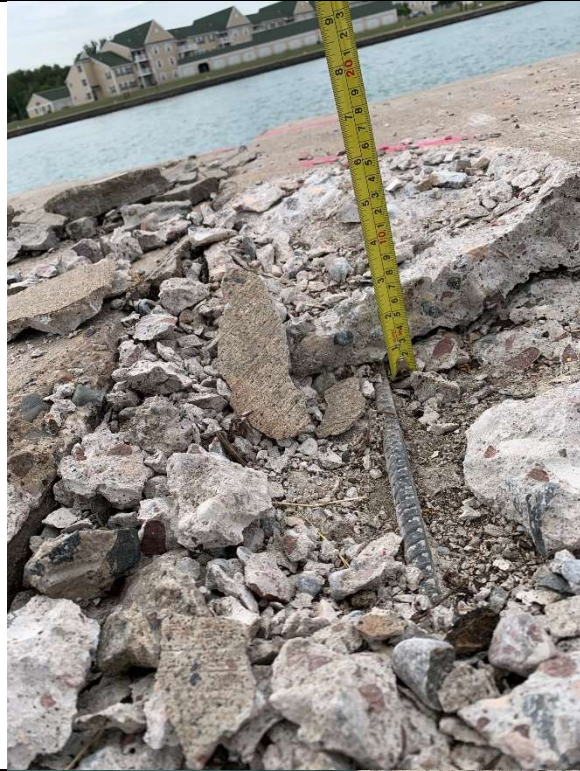
Figure 11 - Spall 2, 18" x 23" x 3" Deep. No visible rebar. West edge of U-20 cell cap repair area

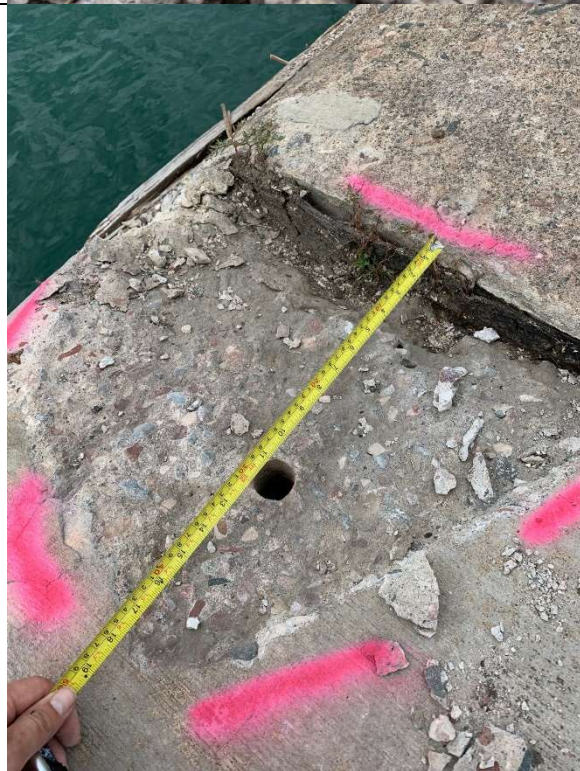
Figure 12 – Spall 3 8" x 12" x 1.5" deep. Rebar exposed along south face at corner; none on top surface

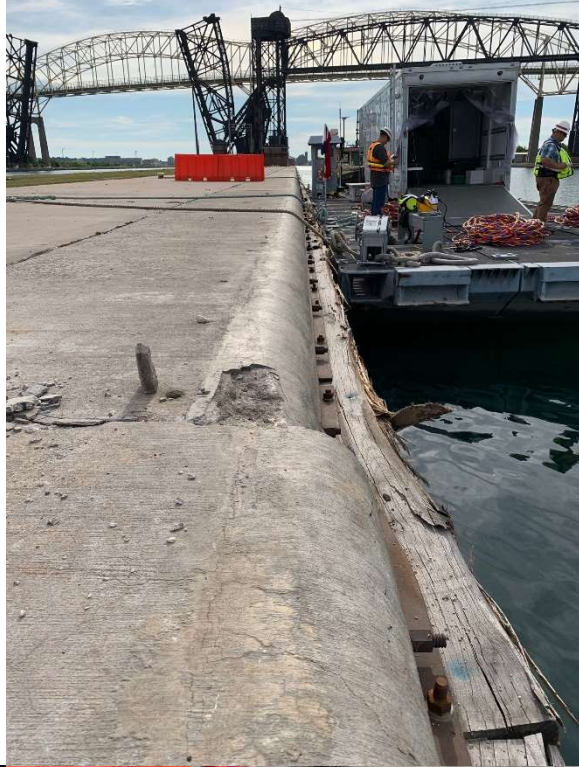
Figure 13 - Joint Material compressed out of joint between timber crib #6 and U-20 cell caps

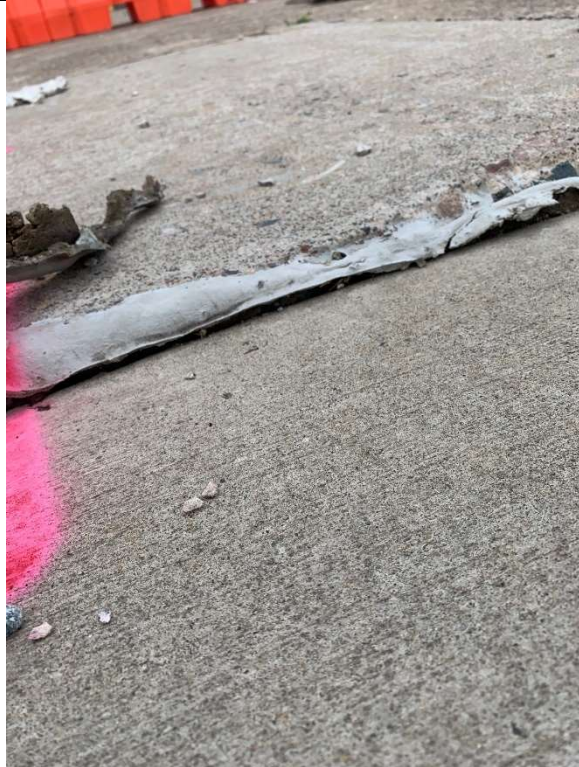
Figure 14 – Displacement of pavement relative to mooring bollard foundation (left is north) of roughly $\frac{3}{4}$ ".

4. Further investigation. Due to the inability to view the existing bollard concrete strut below the concrete pavement surface, further investigation is recommended to assess the strut for damage. A 2' wide trench in the concrete pavement shall be cut-out, starting from the bollard foundation to 3' past the strut mid-point. See Figures A-1 and A-2 for applicable reference drawings. After investigation, the trenches shall be repaired in kind.

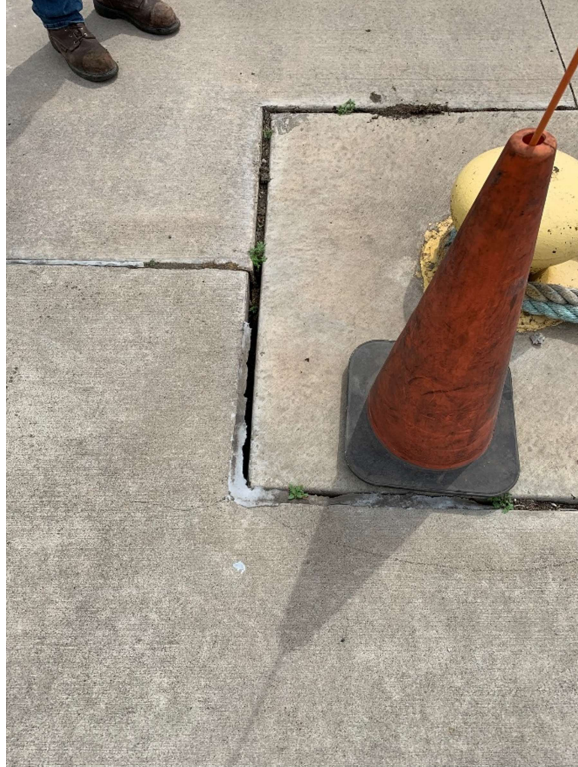
Figure 15 – Rotation of bollard foundation causing south edge elevation to range between $\frac{5}{8}$ " and $\frac{3}{4}$ " above north edge

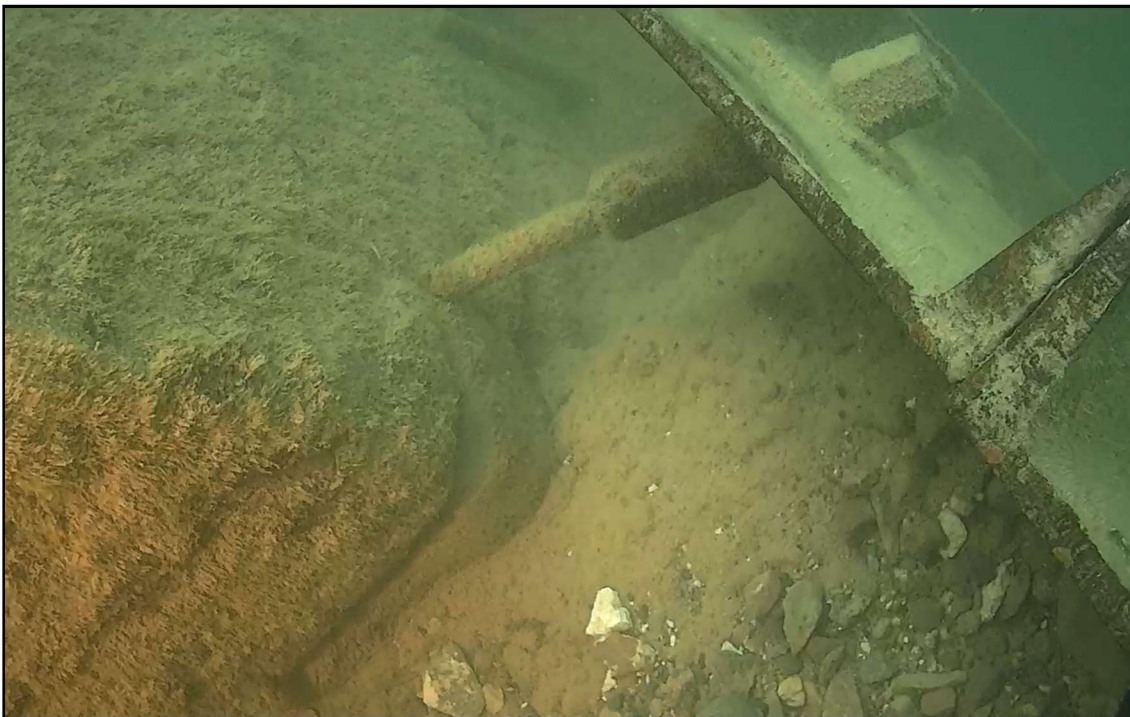
Figure 17 – View East from between crib and cell U-20 bulb at bottom of cap. Approximately 4" to 6" of separation between cap and top crib member. Rolling of top crib member visible.

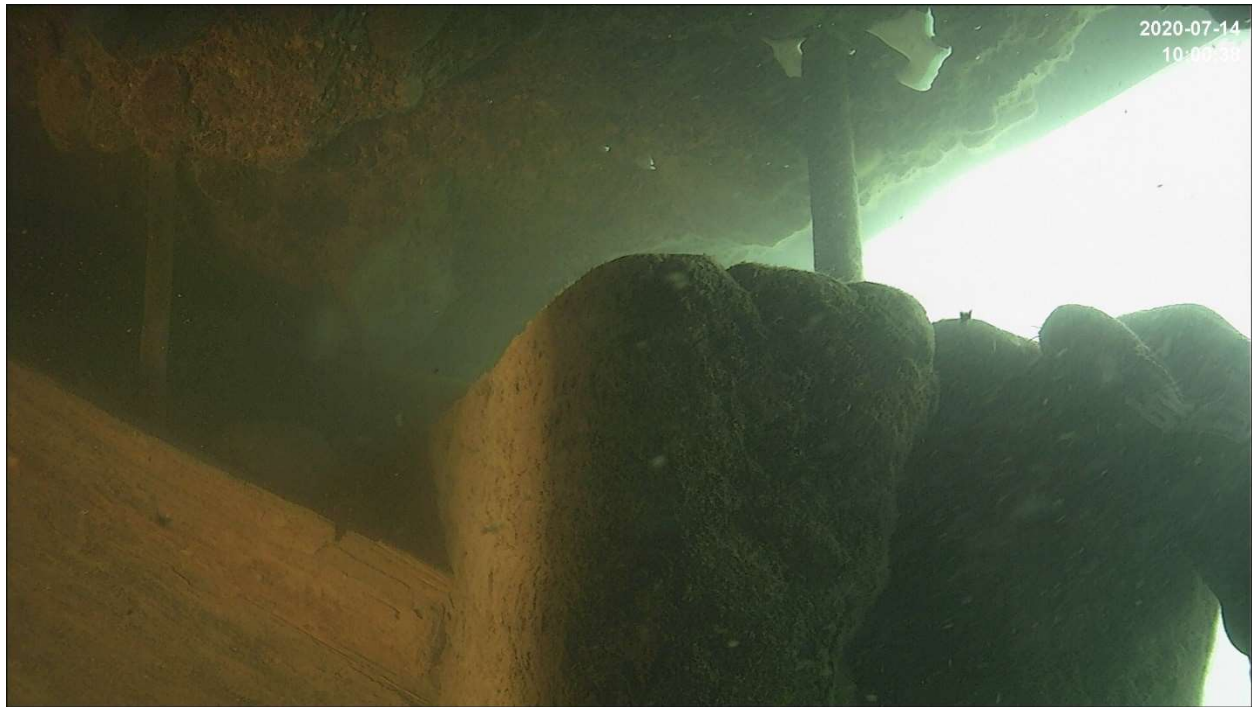
- d. The top horizontal timber appeared to be rolled northward to a greater degree than the crib members below it. This was evident by the large rotation visible and gap present between it and the next crib below it (Figure 18). This may account, at least in part, for the 1 ¼" measured difference mentioned in the previous paragraph. In addition, there was a large gap between the top timber and the bottom of the concrete cap with an exposed steel rod connecting the two. The steel rod had a slight but visible bend northward (Figure 17).
- e. The divers probed into the horizontal crib joints with folding rulers. Probed depths varied from 20" to greater than 70" (Figure 20) due to limited reach with the measuring tools. This indicates that the rock fill material is missing for portions of the upper half of crib (top 7 horizontal timbers).

Figure 18 – Relative rotation of top crib face member (right) and tie-back member (left) visible by gap at square cut end

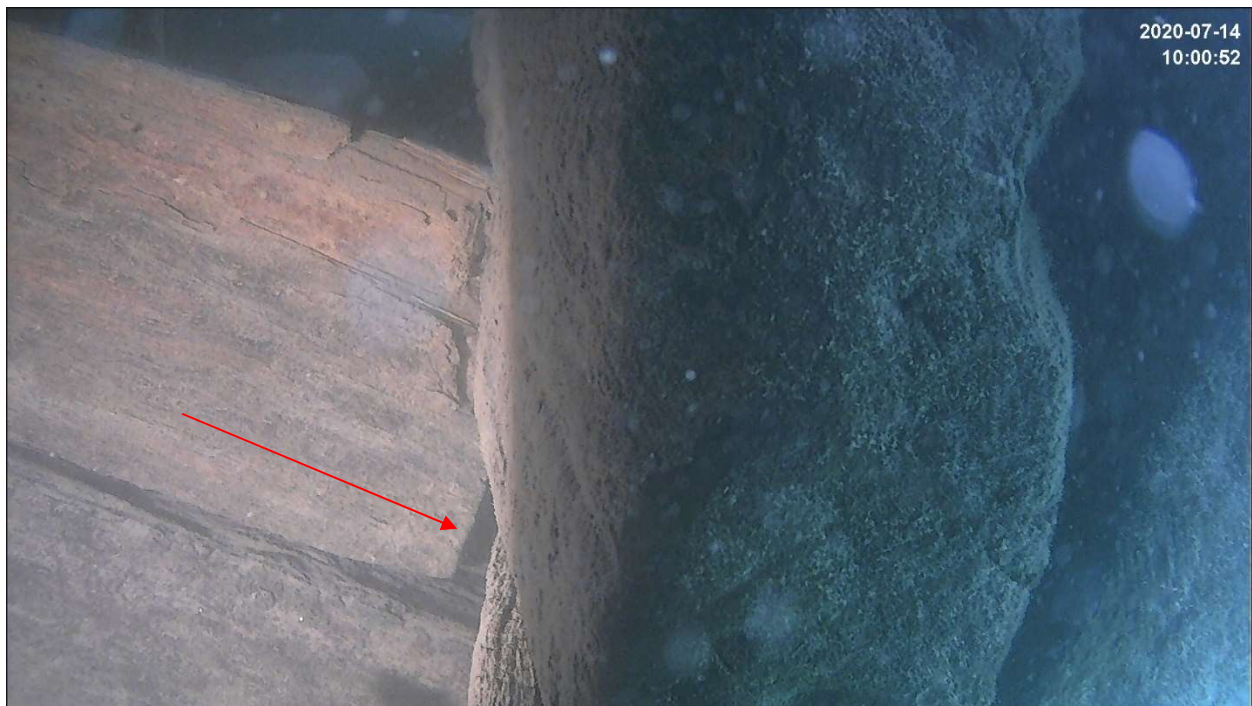
divers were able to take relative measurements from a plumb-bob (hanging on south side of timber fender), which ranged from 24" at the bottom most exposed horizontal timber member (above 1994 rock ledge repair work) to 31" at the top most timber member, a difference of 7" over the exposed crib height. A portion of the 1 ¼" difference between this and the measurement of the cap displacement of 5 ¾" may be due to the accuracy of the underwater measurements and the location of measurements on irregular timber crib surfaces. The measurements verify that the crib members below the concrete cap displaced laterally with the concrete cap. Thus the timber crib has a permanent tilt northward (Figure 19).

Figure 19 – Visible Tilt of timber crib wall (7/5/20 from ROV)

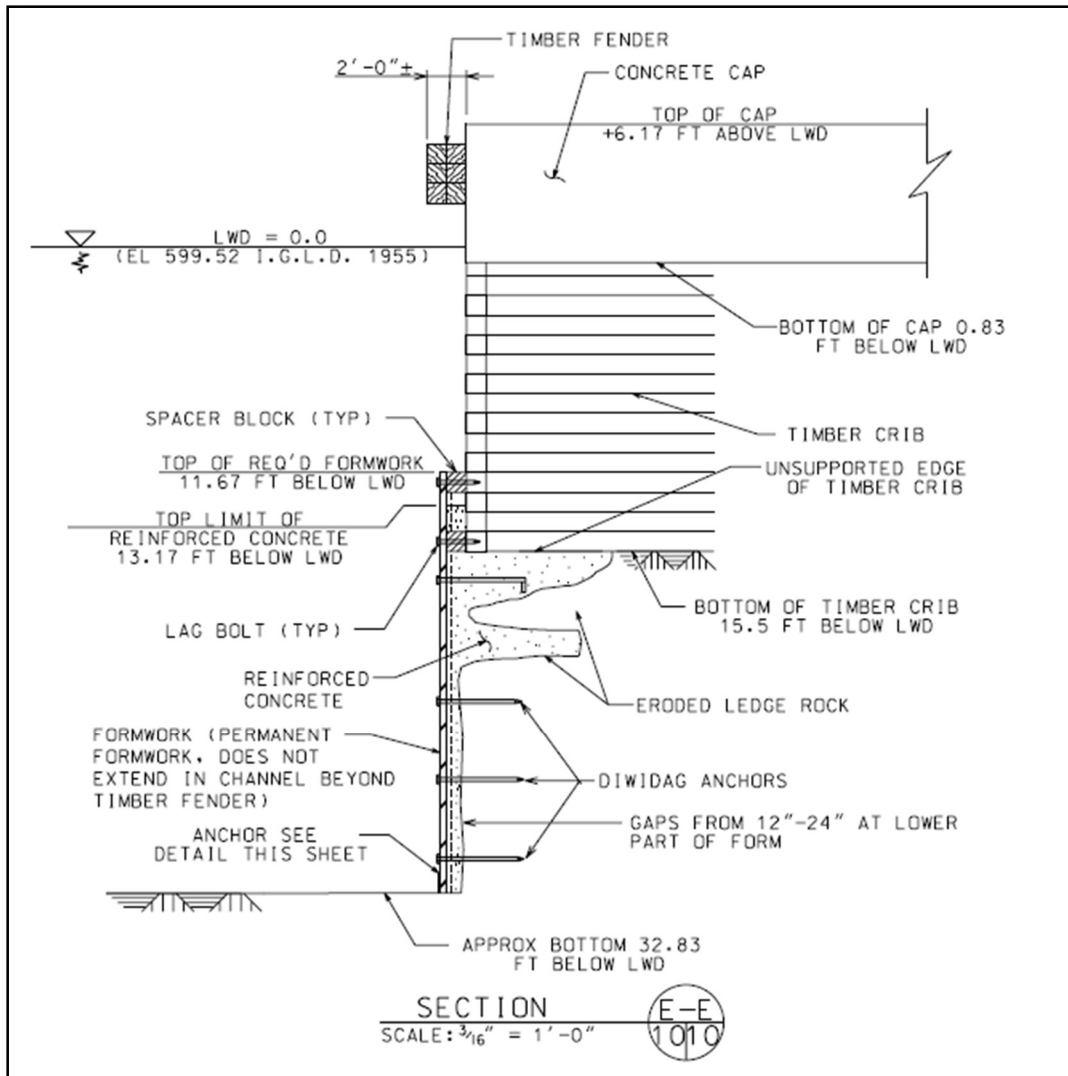
Figure A-9: Multi-beam sonar survey – Rotation of crib wall above 1994 repair area and rolled top crib visible
